# FacadesThree FractureStop Assembly Deck

Date: 06-15-2020 | Detail: F3FS.VI.2 v1

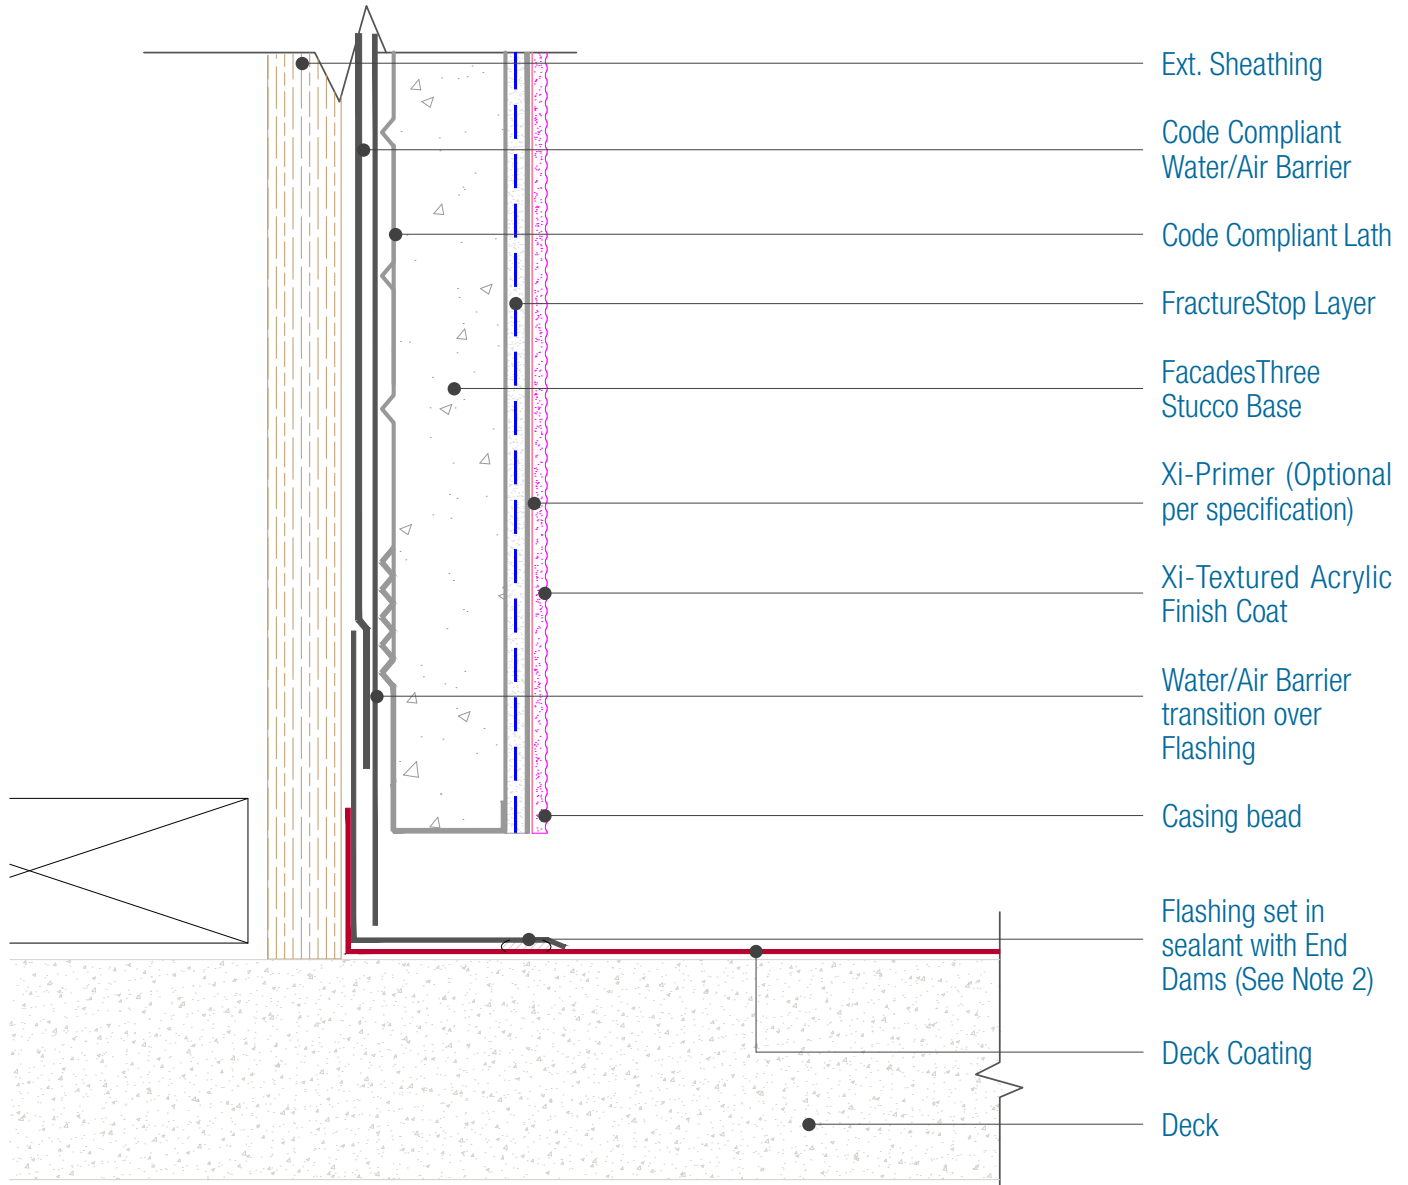
1. See project specifications for approved water/air barrier transition membranes.
2. The flashing is not typically installed by the Plastering Contractor. Responsibility should be determined before construction.
3. Flashing must be watertight, and include end dams if applicable. If the flashing is not installed, backer rod and sealant with weeps is required.
